Inspection Report

Property Address:
123 Sample Street
Fernandina Beach, Florida 32034

Island Inspections, LLC

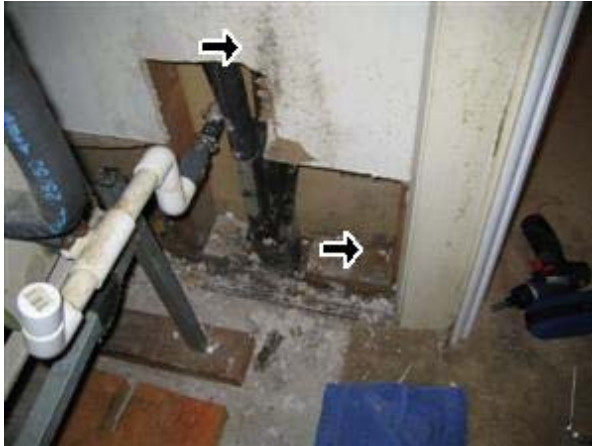
1.2 Picture 1 Right side hall closet

Comments: Visible Evidence Present, (Authorized- sample sent to Lab), Moisture Evidence Present, Potential Concerns

(1) A mold like substance was discovered on the side walls at the filter access of air handler in the hallway. A sample was collected and will be sent to the laboratory. The lab code for this sample is item #1 swab

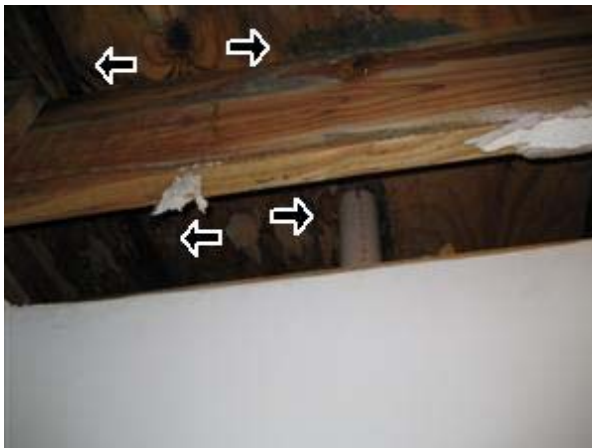
1.2 Picture 3 Master bedroom ceiling

(2) Master bedroom closet showed signs of moisture penetration from above unit. Ceiling also shows signs of mold like substance.

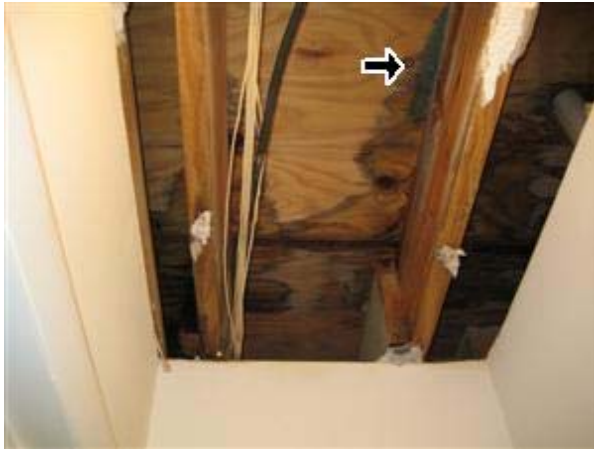
1.2 Picture 5 Mold like substance

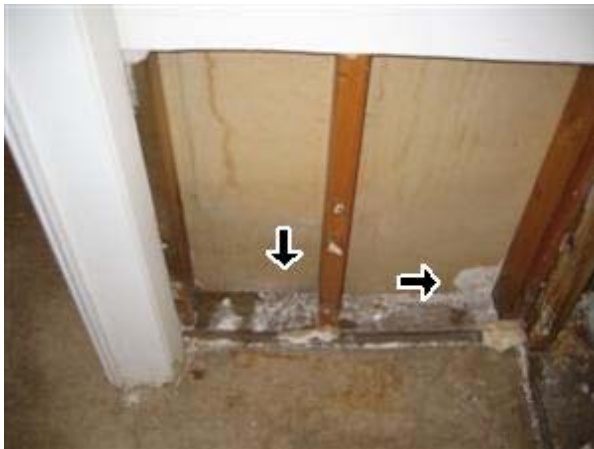
1.2 Picture 6 Master bedroom closet left wall

(3) Bottom of closet show signs of fungus like substance.

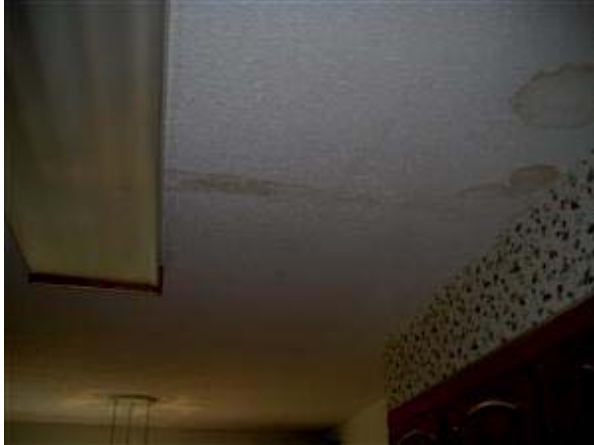
1.4 Picture 1 Kitchen ceiling

Comments: No Visible Evidence, Potential Concerns

Ceiling shows signs of leak. Infrared camera reading indicates moisture still present. I did go in the upstairs unit and ran sink above for five minutes. It appears the moisture is remaining from original issue of upstairs air handler condensate overflowing.

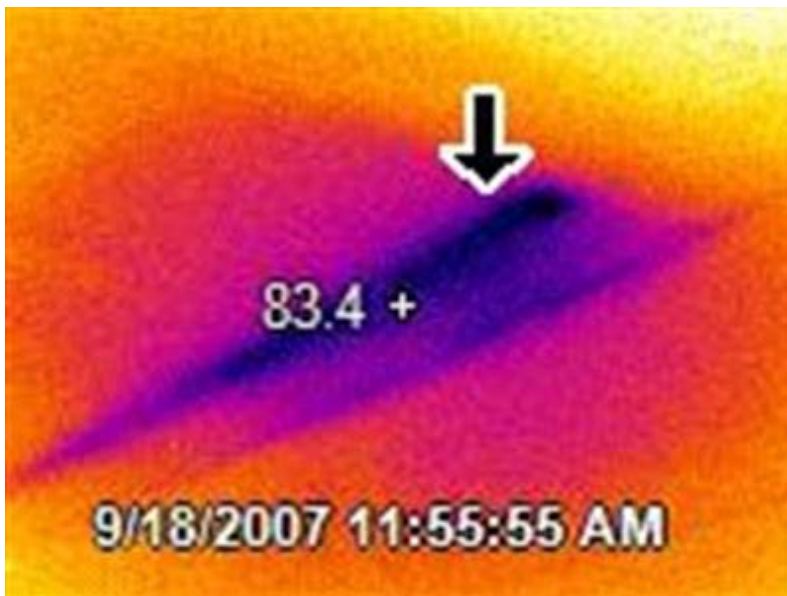
1.4 Picture 2 Blue indicates moisture

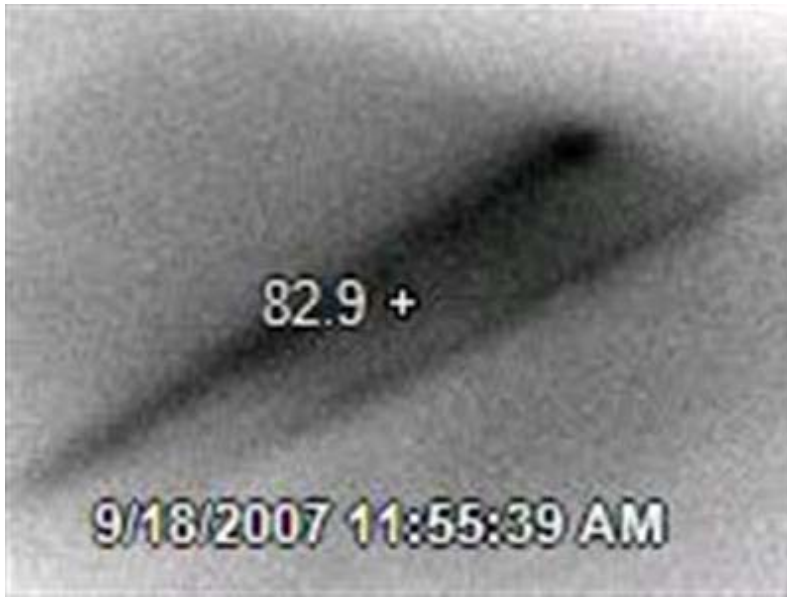
1.4 Picture 3 Black indicates moisture
